Evaluation of Space Power Materials Flown on the Passive Optical Sample Assembly

Evaluation of Space Power Materials flown on the Passive Optical Sample Assembly

1. AGENCY USE ONLY (Leave blank)		2. REPORT DATE April 1999		3. REPORT TYPE AND DATES COVERED Technical Memorandum
4. TITLE AND SUBTITLE Evaluation of Space Power Materials Flown on the Passive Optical Sample Assembly			5. FUNDING NUMBERS WU-632-1A-1F-00

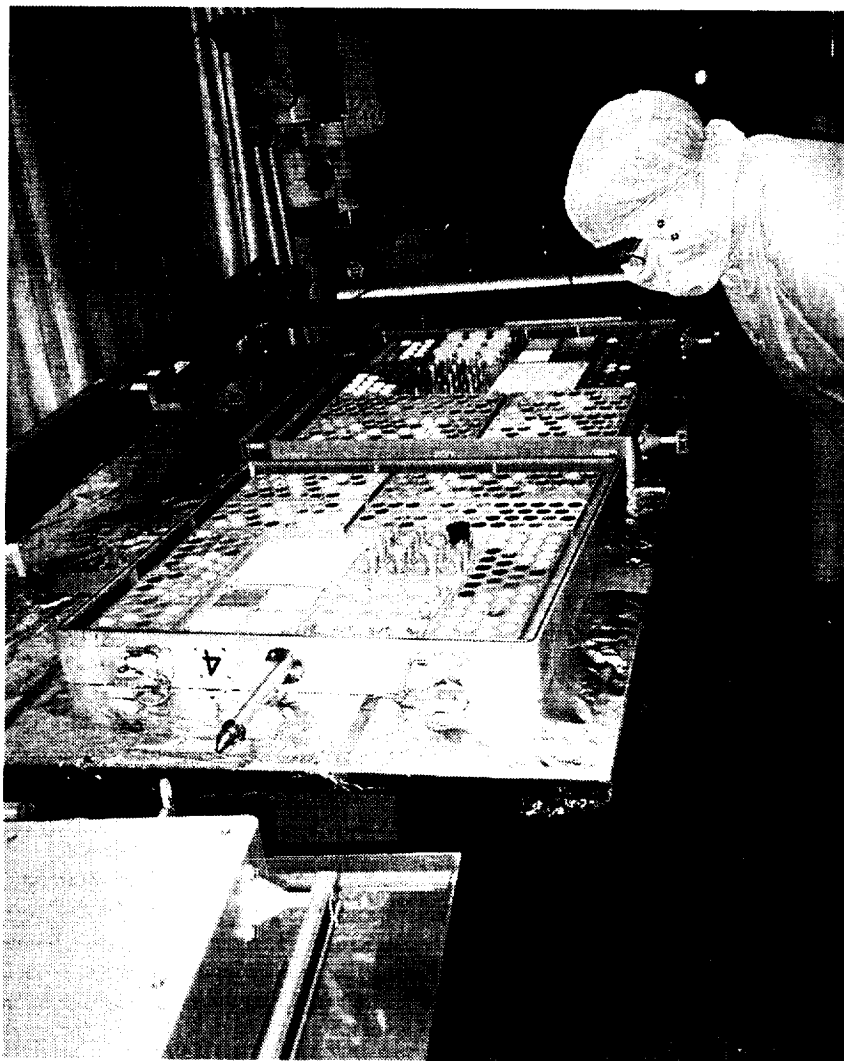
Figure 1a. POSA II package being opened after flight.

Figure 1b. Close up of one sample from the space facing side, showing the spattering of droplets.

Figure 1a shows the POSA II package being opened after flight. In general, the appearance of the returned samples was as expected. There was evidence of atomic oxygen erosion on the unprotected Kapton samples, and there was some discoloration on samples and mounting hardware. It was interesting to note that some regions were not discolored, apparently protected from the source of the discoloring agent due to shadowing. The degree of atomic oxygen erosion was obviously less than expected, because pieces of sacrificial Kapton remained in place. The most obvious and unexpected feature was found on the space facing side of the package, where as shown in Figure 1b there was a spattering across the surface best characterized as the dried remains of droplets. These dried remains are thought to have come from one or more waste water dumps from the space shuttle, while docked to Mir, hereafter referred to as the organic contaminant.

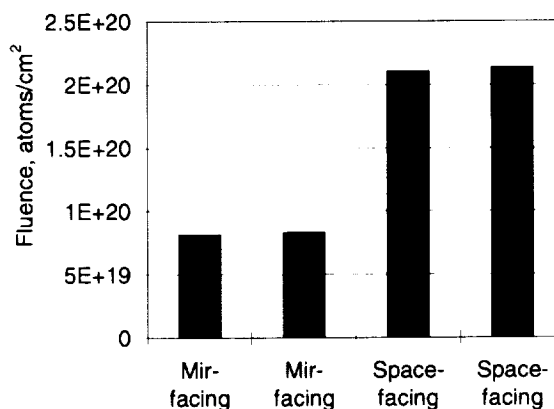
Figure 2. Atomic oxygen fluence measured by Kapton.

Figure 2 summarizes the atomic oxygen fluence measured by the two Mir facing and the two space facing Kapton samples. The two Kapton samples on the Mir facing side of the POSA-2 package both had a mass loss near 0.0012 grams, yielding an estimated atomic oxygen fluence of 8.2×10^{19} atoms/cm². The two Kapton samples on the space facing side of the POSA II package both had a mass loss near 0.0031 grams, yielding an estimated atomic oxygen fluence of 2.1×10^{20} atoms/cm². It is interesting to note that the SiO_x coated Kapton H showed no change in dehydrated mass. With the protective coating of SiO_x, the atomic oxygen fluence was found to be too small for undercutting studies. The absence of change in mass further suggests that the mass of contaminants found on these (and all the other samples including the Kapton samples) was negligibly small.

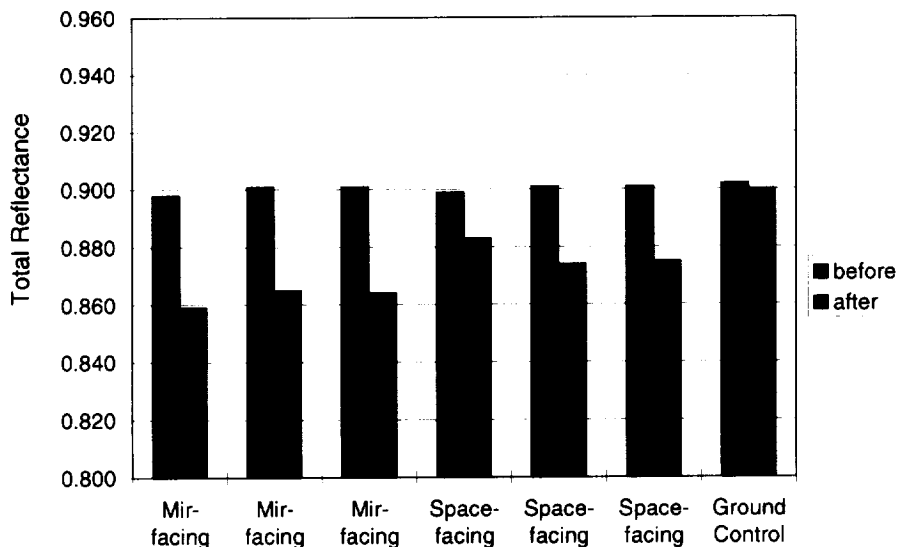
Figure 3. Total reflectance of front surface aluminized sapphire.

Figure 3 shows that the total reflectance of the front surface aluminized sapphire samples decreased as a result of exposure on Mir. On the Mir facing side, the total reflectance decreased, on average, from 0.900 to 0.863. On the space facing side, the total reflectance decreased, on average, from 0.900 to 0.877. Both of these changes suggests a contaminant on the surface, with the thickness of the contaminant being greater on the Mir facing side compared to the space facing side. This non organic contaminant was identified and quantified by variable angle spectroscopic ellipsometry (VASE) at the University of Nebraska ñ Lincoln.

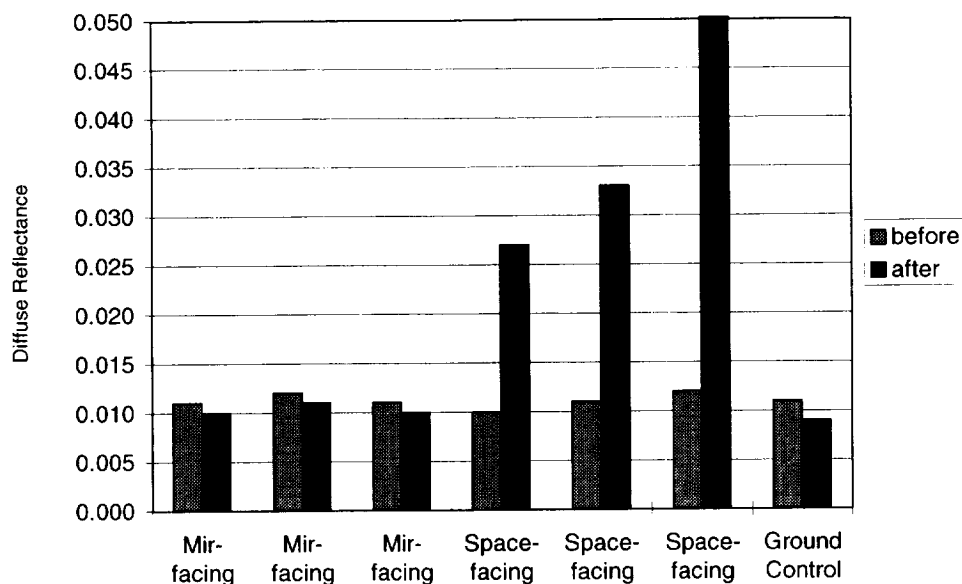
Figure 5. Diffuse reflectance of front surface aluminized sapphire.

Figure 5 shows that the diffuse reflectance of the Mir facing samples remained essentially unchanged, at 0.011, while the space facing diffuse reflectance increased from 0.011 to a maximum of 0.053, undoubtedly due to the organic contaminant mentioned earlier.

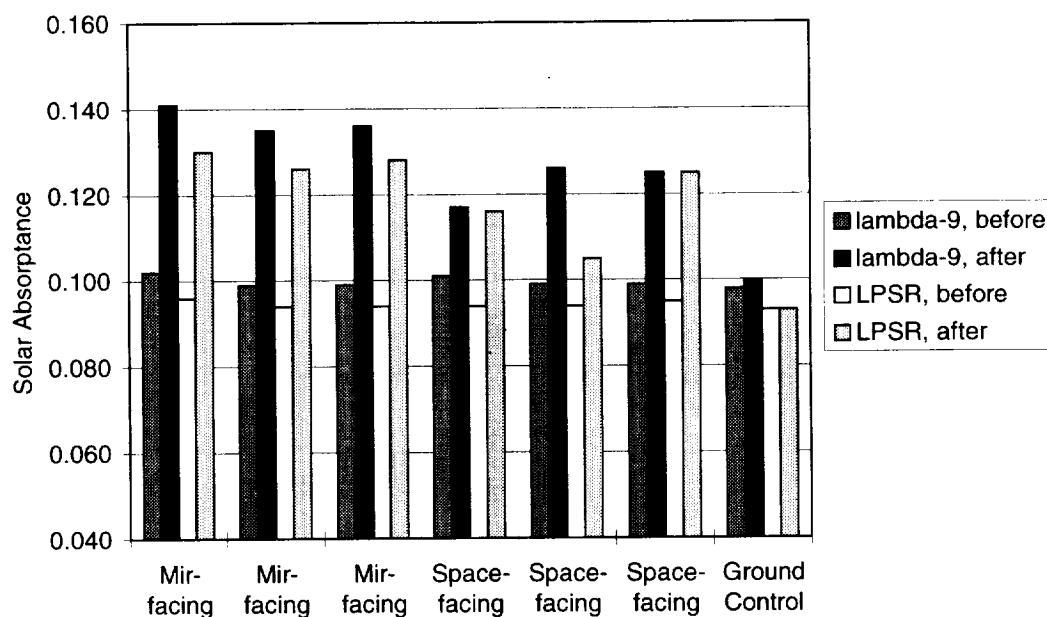
Figure 6. Solar absorptance of front surface aluminized sapphire.

As shown in Figure 6, the inorganic contaminant had the impact of increasing the solar absorptance of these samples, from 0.100 to 0.137 on the Mir facing side, and from 0.100 to 0.123 on the space facing side. The organic contaminant is thought to be responsible for the increase in emittance observed on the space facing samples, as seen in Figure 7.

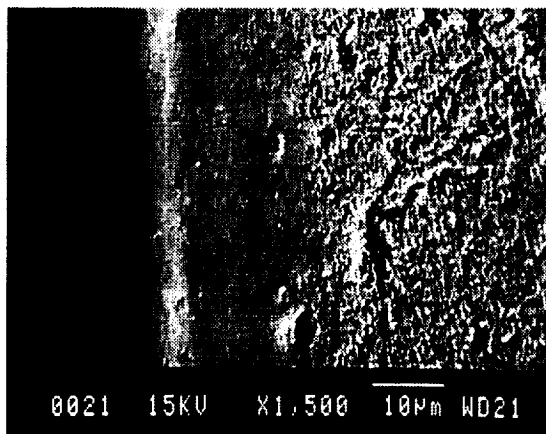
Figure 16a. Protected, shadowed, and unprotected Kapton, Mir facing.

The partially eroded Kapton was successfully used for scanning electron microscopy (SEM). Features from the Mir facing samples are summarized in Figure 16. The Kapton was both textured and covered with contaminant. One SEM photograph showed a particle on the surface and indicates the oblique angle of atomic oxygen arrival, where some material was protected from atomic oxygen on the shadowed side of the particle. One crater-like impact site was found. The textured/contaminated surface of the Kapton was interrupted by an occasional splatter pattern. Further texturing seems to have occurred in the center of the splatter patterns. Features from the space facing sample are summarized in Figure 17. In this case, the Kapton was noticeably textured. One region showed some streaking, similar to the splatter pattern seen on the Mir facing side. However, the streaking on the space facing side is better characterized as texture that was somehow knocked down. Another particle found on the surface, shows a protected "mesa" with atomic oxygen texturing in the background. An SEM photograph of the dried organic contaminant is shown. Also shown is a region where the organic contaminant was purposely washed off. It is interesting to note the step at the interface between the area of erosion and the area of Kapton previously covered by contaminant, suggesting that the contaminant was present for some time.

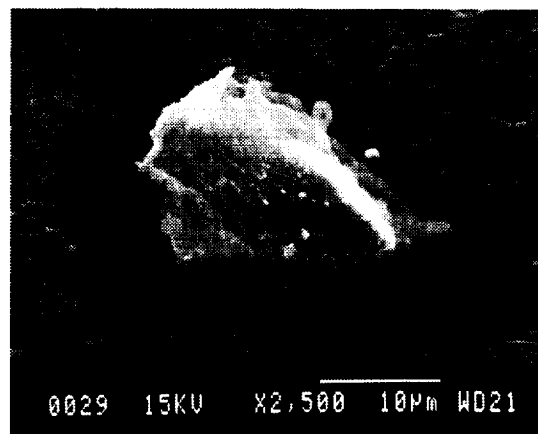
Figure 16b. Particle showing oblique angle of atomic oxygen arrival.

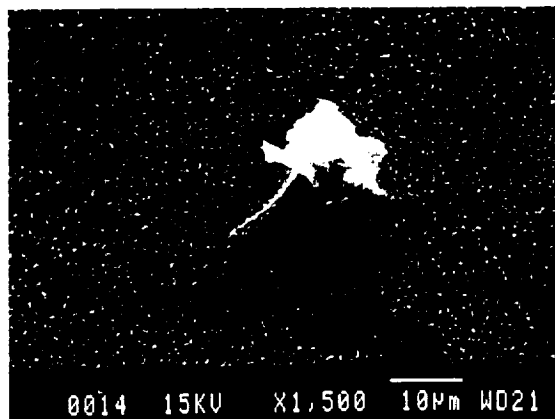
Figure 17b. Protected "mesa" with atomic oxygen texturing in the background.

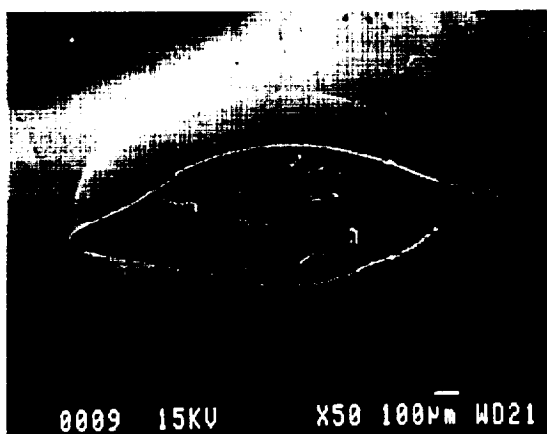
Figure 17c. Organic contaminant, uncleaned.

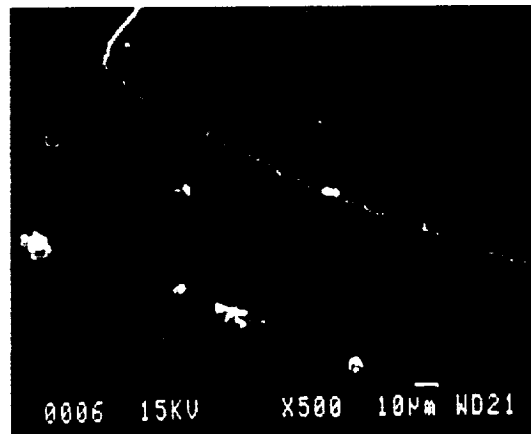
Figure 17d. Texturing near organic contaminant, after cleaning.

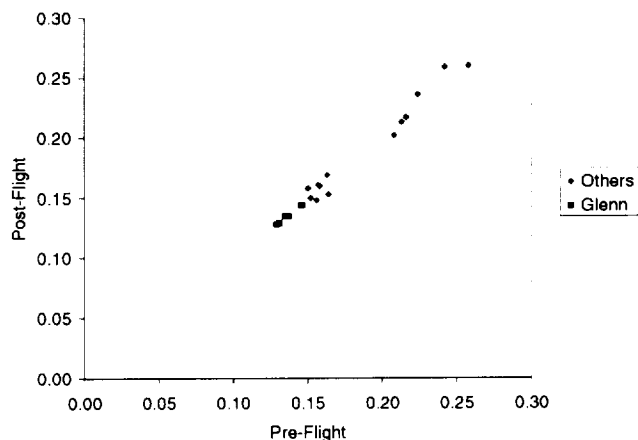
Figure 18. Pre-flight versus post-flight solar absorptance for Glenn samples, and others on POSA II.

There was little to no change in the solar absorptance of the Z-93-P samples characterized by Glenn, and only a small change in their infrared emittance. Figure 18 summarizes the pre-flight vs. post-flight solar absorptance for several Z-93-P samples on POSA II, including the Glenn samples. Figure 19 summarizes the pre-flight vs. post-flight infrared emittance for the same samples. The decrease in infrared emittance was less pronounced in Glenn samples compared to the other samples on POSA II.

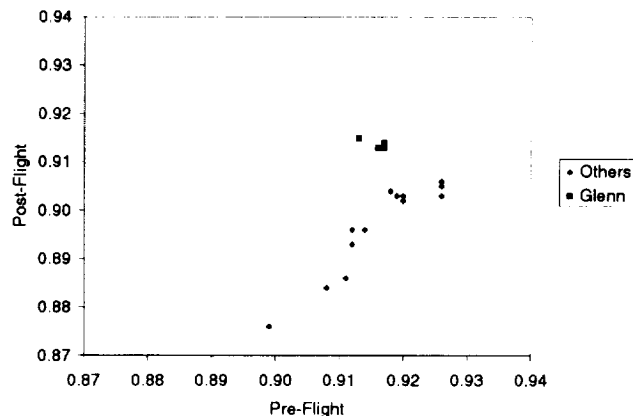
Figure 19. Pre-flight versus post-flight emittance for Glenn samples, and others on POSA II.
